Lake Kounpee - Grout Wall Complete

By Peter Tighe

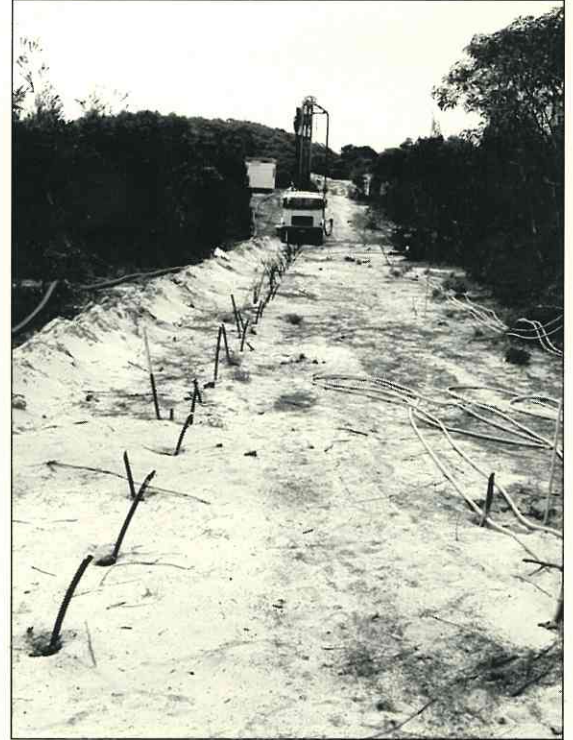
Installing the grout wall

To achieve the planned design required 10 000 bags (300 tonnes) of microfine cement slurry to be injected below the surface through 275 poly pipes installed vertically at 1 metre spacing. Slade Drilling were contracted to drill and install the poly pipe - a total of nearly 10 kilometres of 20mm black poly pipe. The bottom of the pipe had to be accurately positioned at the planned bottom of the grout wall.

Groutech Pty Ltd used specially constructed mixing and pumping stations to inject the microfine cement into the pipes, pulling back the pipe in one metre lifts and injecting the cement until the planned top of the wall was reached. The grouting took six weeks to complete.

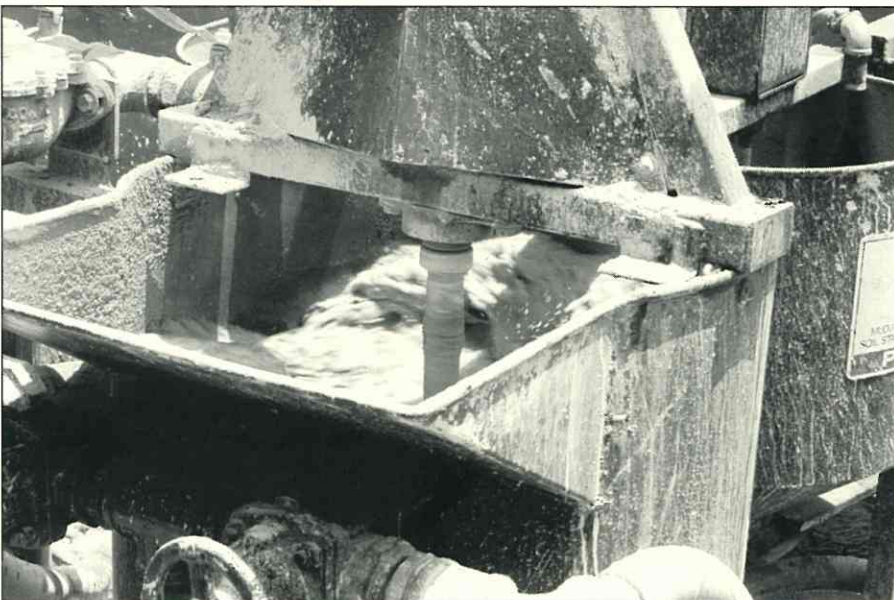
Mixing the grout
