Case Study GrouTech—saving time & money

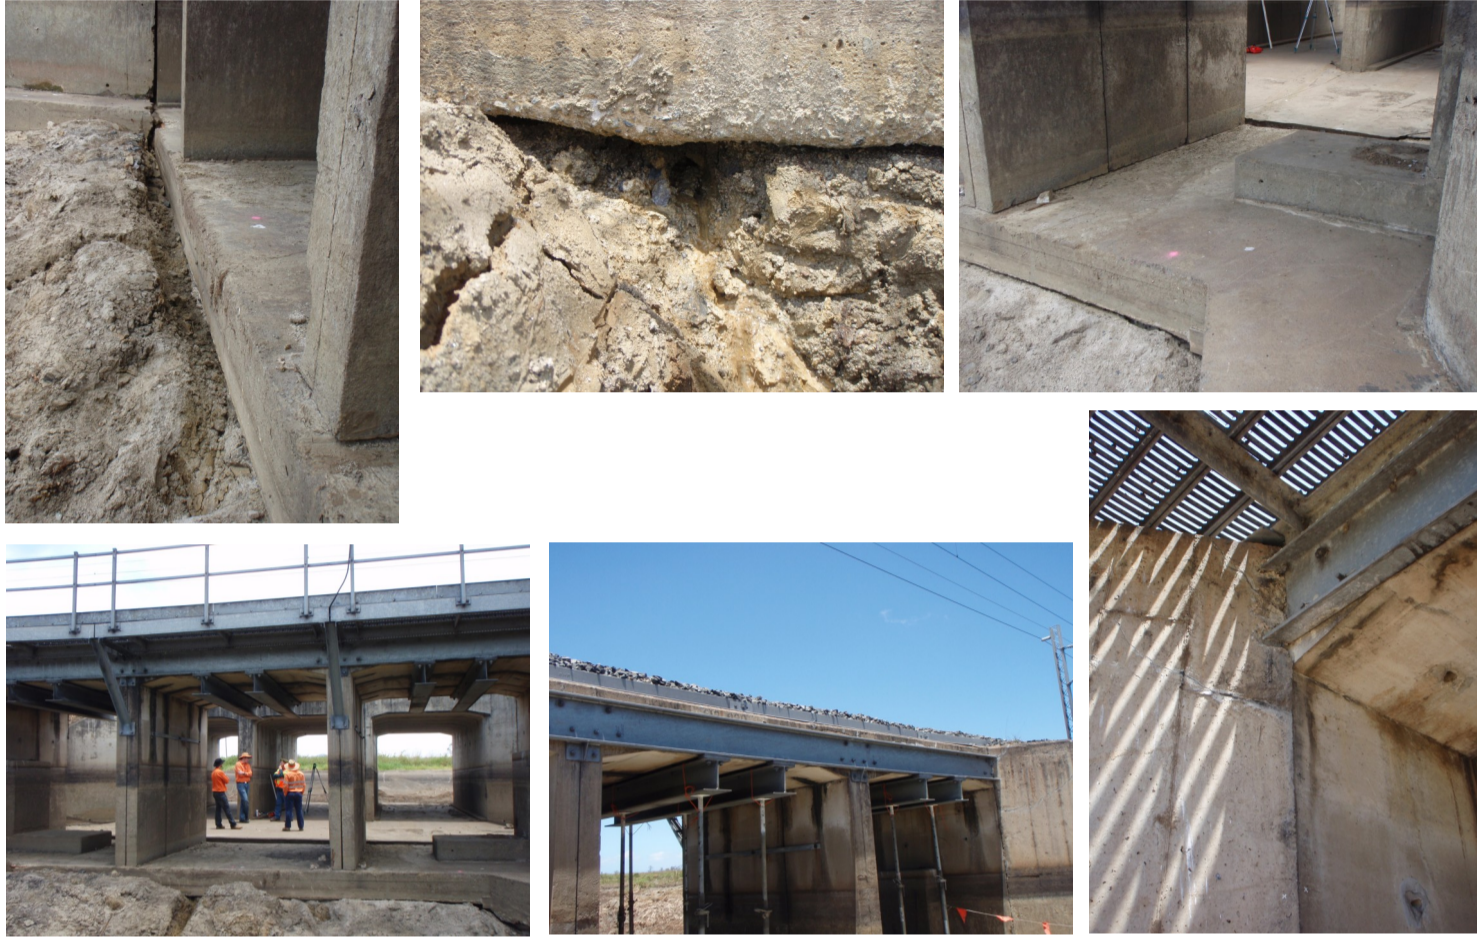
When trains went over the culvert, one end was deflecting up to 150mm. The base slabs had subsided – dragging the culvert walls down. The risks of losing a load and having a derailment was considered high enough for speed restrictions to be put in place until rectification and support of the culvert took place.

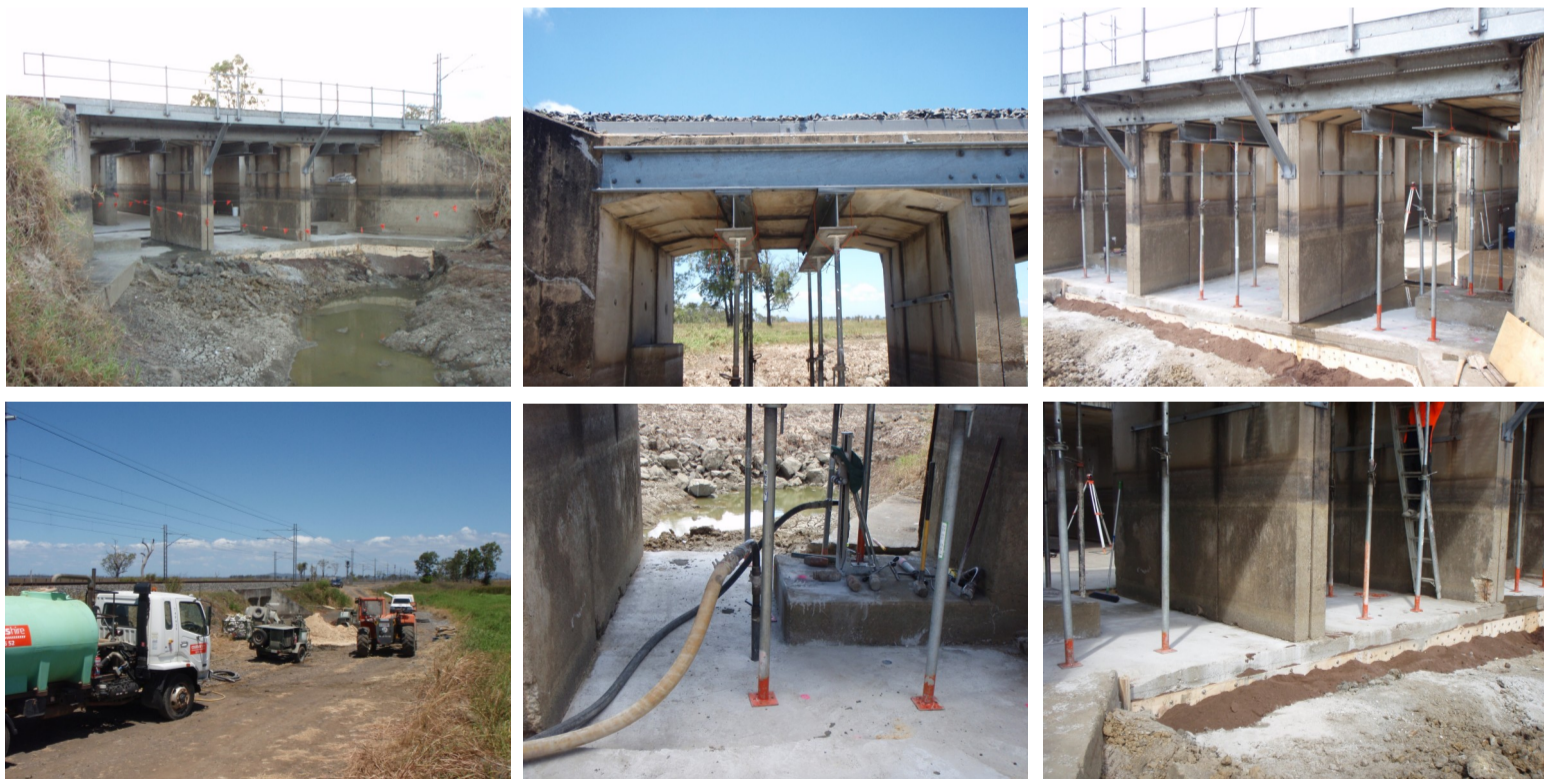
GrouTech met with QR National to discuss potential rectification options. Two days after the first meeting GrouTech had established on site. The structure was braced and grout was injected below the structure to stabilise against movement. Strength of the grout was 40MPa, pumping pressures around 1500KPa.

- *400 mm of compaction grout pumped beneath the structure to compress the clay by 10-12%.
- *Water was squeezed out of the pores in the clay.
- *Project completed without removal of the ballast or the rail.
- *40mm of lift achieved as well.
- *Line has been monitored for 12 months – there is a recorded deflection of 0mm during traffic.
- *Initially hoping for a 3-5 year solution before replacing the structure.
- *Based on the outcome achieved the culvert is not going to be replaced.
